BARRIER FENCE 2" FENCE SYSTEM WIND TESTING APRIL, 2022

WIND TESTING

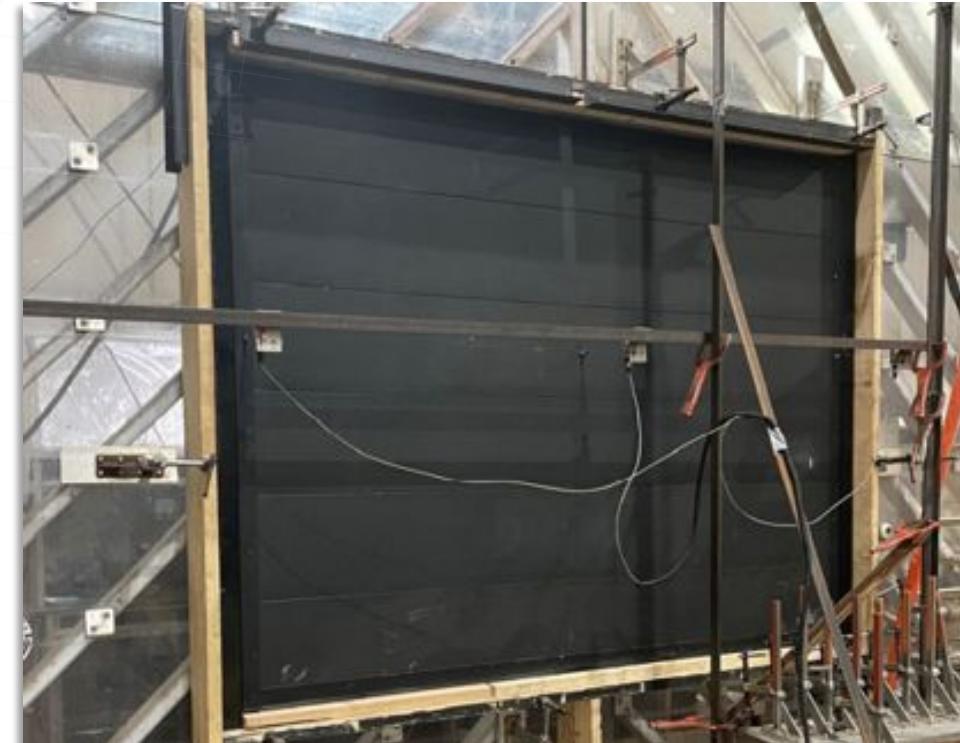
Uniform Proof Load per ASTM E330-14

2-mil plastic film was used to prevent air leakage during testing. It is the opinion of the test technician that this film did not influence the results of the test.

Applied Load:	2080 Pa (43.5 psf)*	
Vertical Post Above Anchorage	PASS	
Span(L):	1905 mm (75 in)	
Net Deflection:	119.4 mm (4.70 in)	No permanent damage
Net Permanent Set:	16.3 mm (0.64 in)	
Horizontal Panel Member	PASS	
Span (L):	2261 mm (89 in)	
Net Deflection:	12.6 mm (0.50 in)	No permanent damage
Net Permanent Set:	0.4 mm (0.02 in)

*Fence panel passed laboratory simulated wind speed testing of 210 kph.

*The specimen passed a 44 psf load. Failure occurred during a 48 psf load. The vertical posts yielded at the anchorage interface.

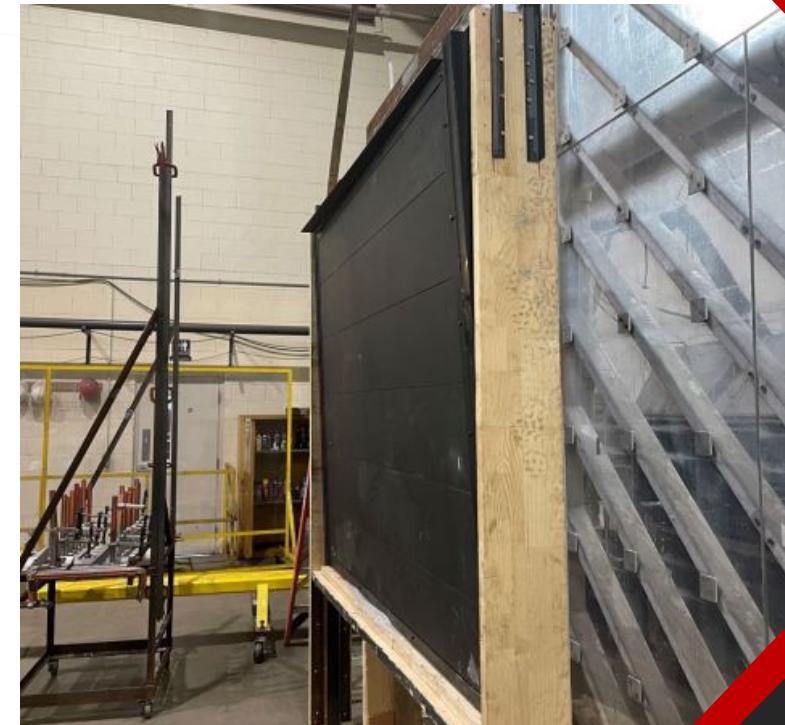
Uniform Design Load per ASTM E330-14

2-mil plastic film was used to prevent air leakage during testing. It is the opinion of the test technician that this film did not influence the results of the test.

Applied Load: 1390 Pa (29.0 psf)

Vertical Post Above	PASS
---------------------	------

Span(L): 1905 mm (75 in) No permanent

Net Deflection: 68.1 mm (2.68 in) damage

Horizontal Panel Member	PASS
-------------------------	------

Span (L): 2261 mm (89 in) No permanent

Net Deflection: 7.7 mm (0.31 in) damage
